PROPERTY INSPECTION REPORT

Concerning: 1234 STREET DR City, State 12345
(Address or Other Identification of Inspected Property)

By: Brian Keith Moxley #10448 Jan 1, 2010
(Name and License Number of Inspector) (Date)

Report Identification: 1234 STREET DRIVE CITY, STATE 12345

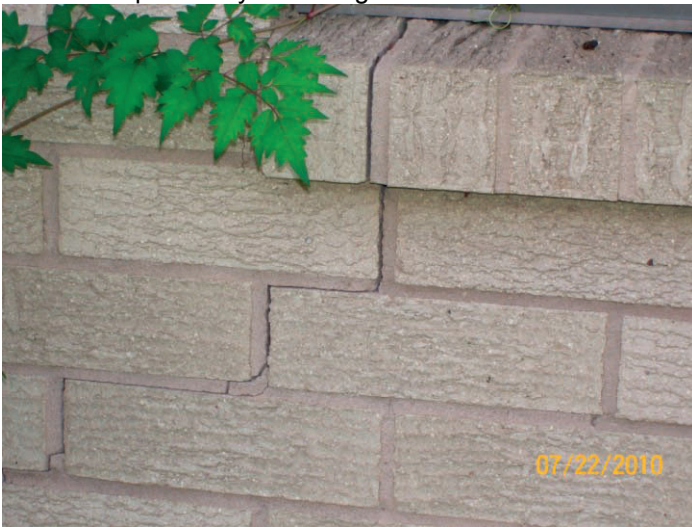
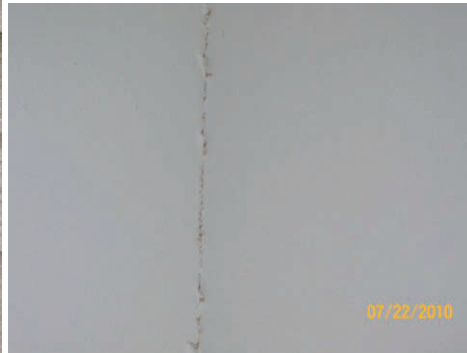
Deflection cracks were observed in the exterior veneer.

Misalignment of interior doors due to foundation movement.

Interior sheetrock cracks and/or stress indicators.

Note: Tree(s) in close proximity of the foundation was observed. Client should consider the installation of a root barrier to reduce the possibility of damage to the foundation from tree roots and moisture removal.

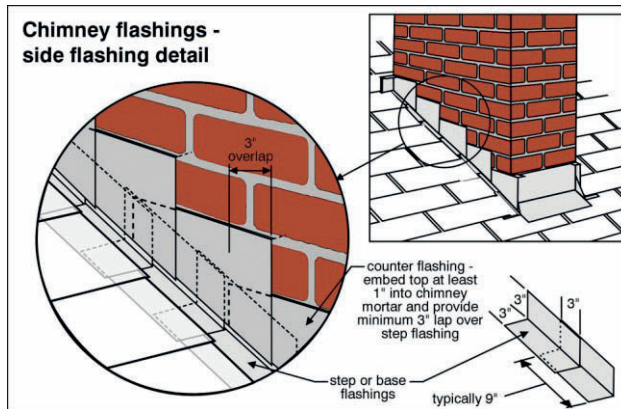
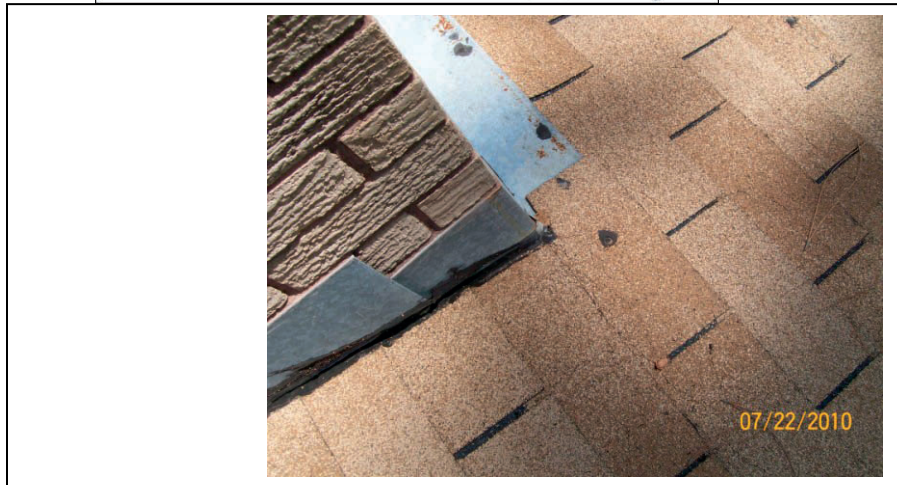
Note: Roof fasteners (nails and/or staples) were observed to be exposed and should be properly sealed at the ridge caps and flashing areas.

Damaged shingle tabs were observed on the north and east sides of the roof structure.

The roof level chimney flashing details need to be checked, reset or repaired. There is visible evidence of water intrusion at and around this location.

Note: The tree and shrub branches should be trimmed away from the roofing material at all times.

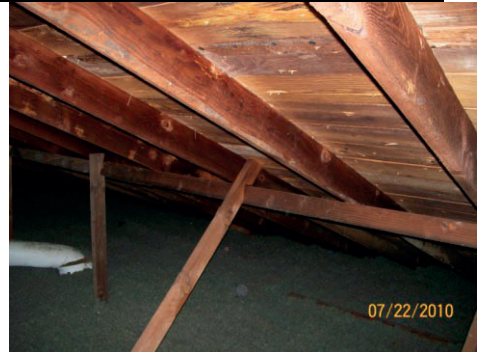
Note: The roof structure purlins are not properly sized to the rafters they support and the purlins are not properly supported. This item met building standards at the time the home was built. The building standards have changed and

Per TREC standards of practice we are required to note this item as a deficiency.

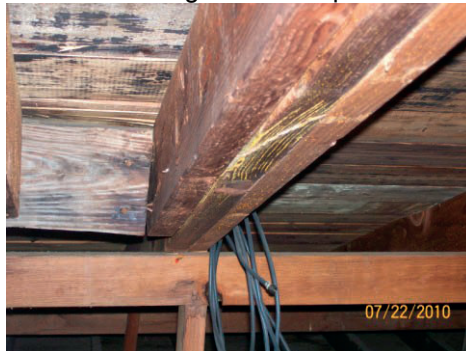
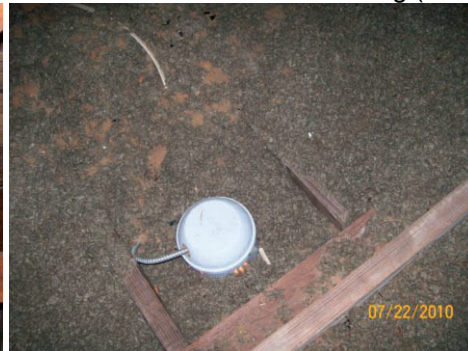
The roof structure attic space does not appear to be adequately ventilated. This condition should be further evaluated and corrected as necessary.

One or more of the roof structure collier-ties were observed to be pulled loose in the attic area.

The attic insulation was observed to be covering the recessed lights. The insulation should be moved away from all recessed lights to help prevent overheating.

There is an inadequate fireblock observed between the units. A complete vertical and a four-foot (4-ft.) horizontal fireblock separation of a two-family dwelling are required at the line of dwelling unit separation.

Some noticeable sags and/or depressions were observed in the roof sheathing (decking).

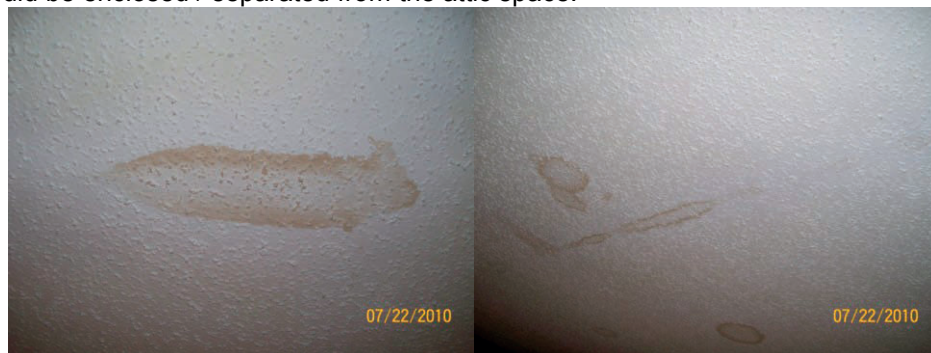
Ceiling sheetrock stress cracks were observed in various locations throughout the house.

Water stains were observed on the ceiling finish material in various locations throughout the house. The cause and remedy should be further evaluated and corrected as necessary.

Ceiling surface damage was observed in the utility room.

The garage ceiling is opened to the attic space. Under current building standards the garage ceiling should be enclosed / separated from the attic space.

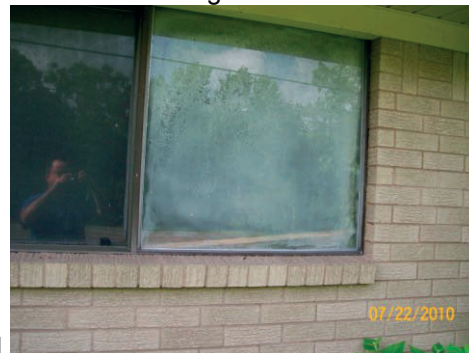
The window weather-stripping is damaged and/or missing at one or more of the windows and improvements are recommended.
 The window glass glazing-compound is damaged and/or missing at one or more of the windows and improvements are recommended.
 Cracked and/or broken window glass was observed in the family room.
 The window lock(s) do not appear to be latching properly in various locations throughout the house.
 One or more of the window screens were observed to be missing.

One or more of the window screens were observed to be damaged.

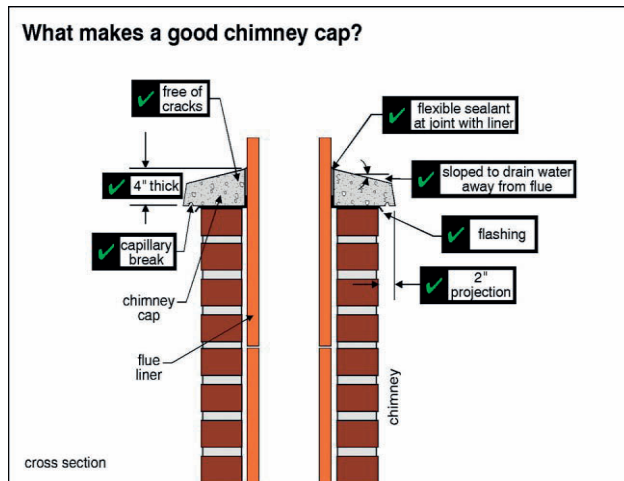
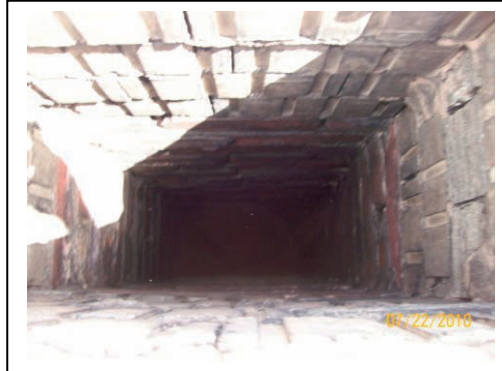
The chimney flue needs to be cleaned by a Qualified Chimney Sweep. A creosote / soot build-up was observed in the visible flue area.

The roof level chimney mortar cap/crown is in need of improvement.

The metal chimney flue cap is missing. This condition should be further evaluated and corrected as necessary.

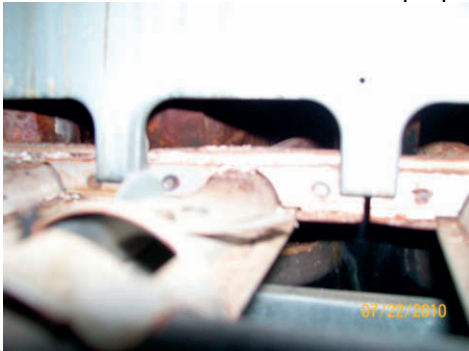
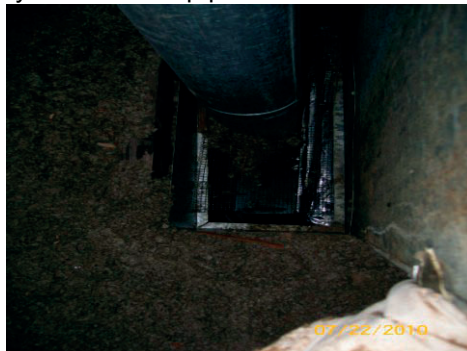
Excessive scaling, soot build-up and/or debris were observed on or around the burners.

The roof level flue storm collar needs to be properly sealed to help prevent water intrusion into the

structure.

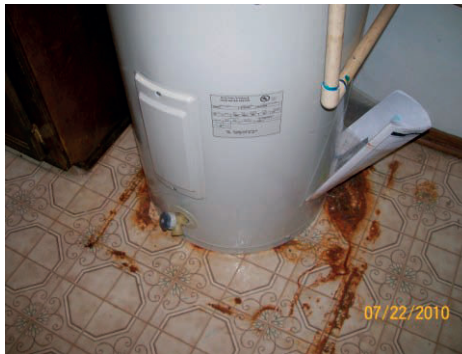
Some corrosion was observed at the water supply connections at the top of the water heater.

There is no pan installed under the water heater.

P2801.5 Required pan. Where water heaters or hot water storage tanks are installed in locations where leakage of the tanks or connections will cause damage, the tank or water heater shall be installed in a galvanized steel pan having a minimum thickness of 24 gage (0.016 inch) (0.4 mm) or other pans for such use. Listed pans shall comply with CSA LC3.

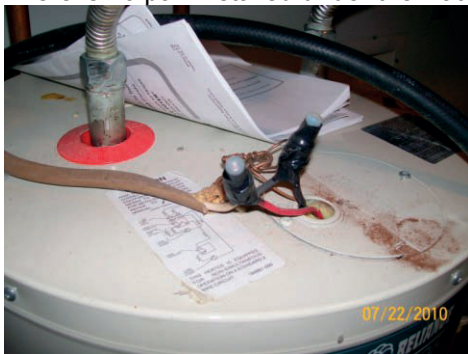
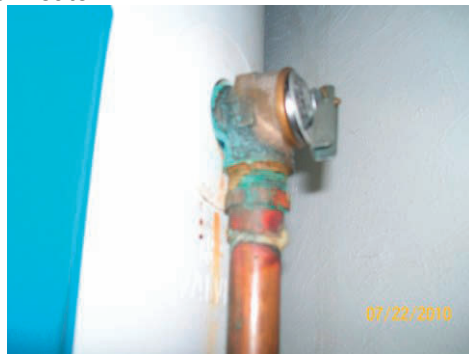
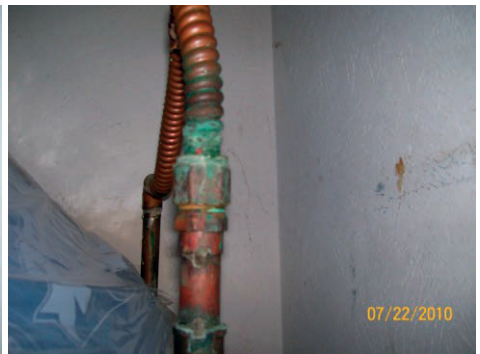
The plastic tubing / piping being used for the temperature and pressure relief (TPR) valve discharge pipe is not listed nor labeled for this type of use.

5. Discharge to the floor, to an indirect waste receptor or to the outdoors. Where discharging to the outdoors in areas subject to freezing, discharge piping shall be first piped to an indirect waste receptor through an air gap located in a conditioned area.
6. Discharge in a manner that does not cause personal injury or structural damage.
7. Discharge to a termination point that is readily observable by the building occupants.
8. Not be trapped.
9. Be installed to flow by gravity.
10. Not terminate more than 6 inches (152 mm) above the floor or waste receptor.
11. Not have a threaded connection at the end of the piping.
12. Not have valves or tee fittings.
13. Be constructed of those materials listed in Section P2904.5 or materials tested, rated and approved for such use in accordance with ASME A112.4.1.

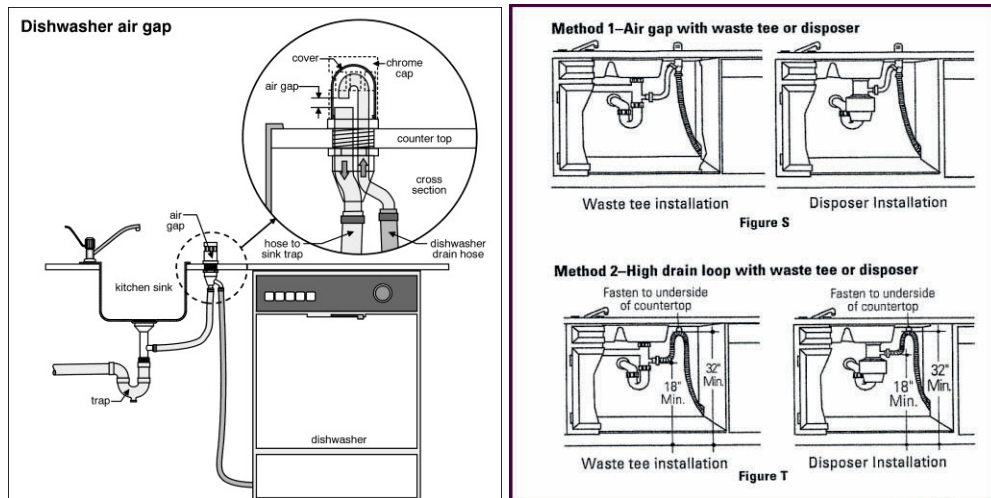
The dishwasher drain hose is not properly installed to prevent back flow or anti-siphoning. It is recommended that an air gap device or high drain loop be installed in the drain line.

Note: There is evidence of prior leakage in the vicinity of the dishwasher. This should be monitored.

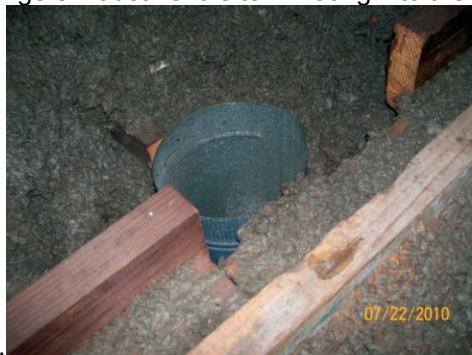
The range exhaust vent is terminating into the attic area. Range exhaust vents should vent to the exterior of the

house.

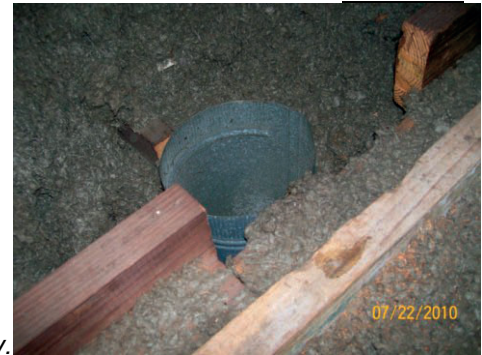
The mechanical exhaust vents were observed to be venting into the attic area. Under current building standards, all mechanical exhaust vents should vent to the exterior of the structure. This is an **“as-built”** condition but *Per TREC*

standards of practice we are required to report this condition as a deficiency.
